Intel® Rapid Storage Technology enterprise (RSTe) 4.3.0.1223 Customer Release Notes

Aug, 2015

Revision 1.43

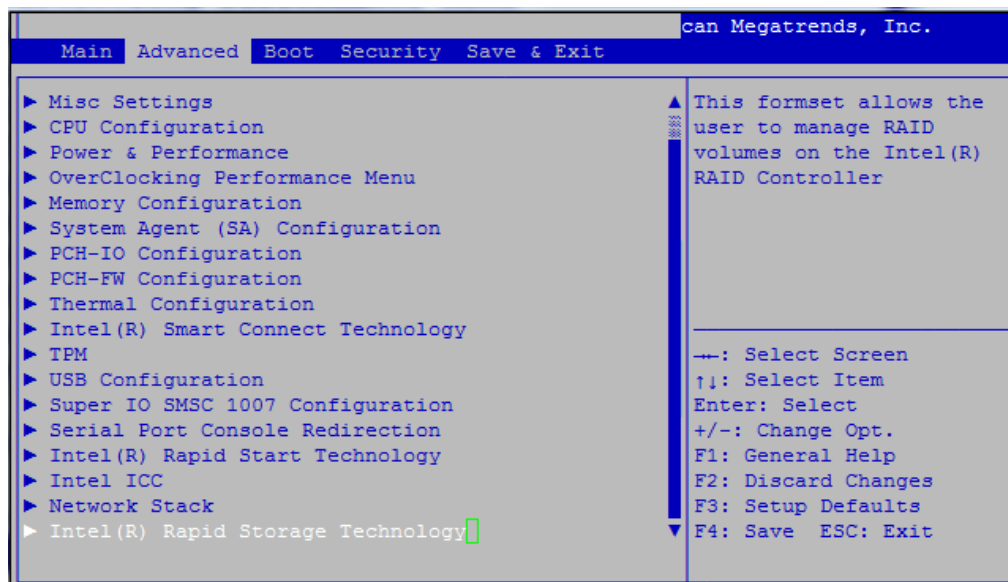
With the release 3.7.0.1093, customers will be able to configure RAID volumes using Intel® RSTe UEFI Human Interface Infrastructure (HII). HII is a simple “Walk Up and Use” interface that allows users to create, delete, and manage RSTe RAID Volumes within the BIOS Setup Menu.

The UEFI driver will provide an entry point which can be called to invoke the HII interface. The entry point can be called from any place in the BIOS UI that an IBV chooses.
